Full scale testing of wind turbine blade to failure - flapwise loading

Abstract A 25m wind turbine blade was tested to failure when subjected to a flapwise load. With the test setup, it was possible to test the blade to failure at three different locations.

The objective of these tests is to learn about how a wind turbine blade fails when exposed to a large flapwise load and how failures propagate.

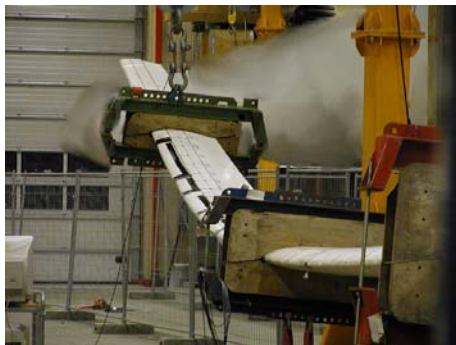
In test of section 1 (19.3m to 23.3m) the blade failed 20.1m from the root, with a load introduction as given in figure 4. In the figures below the large deflection in this test is seen as well as a picture of the failed section of the blade.

Figure 7 Test of section 1, large deflection is seen in this test.

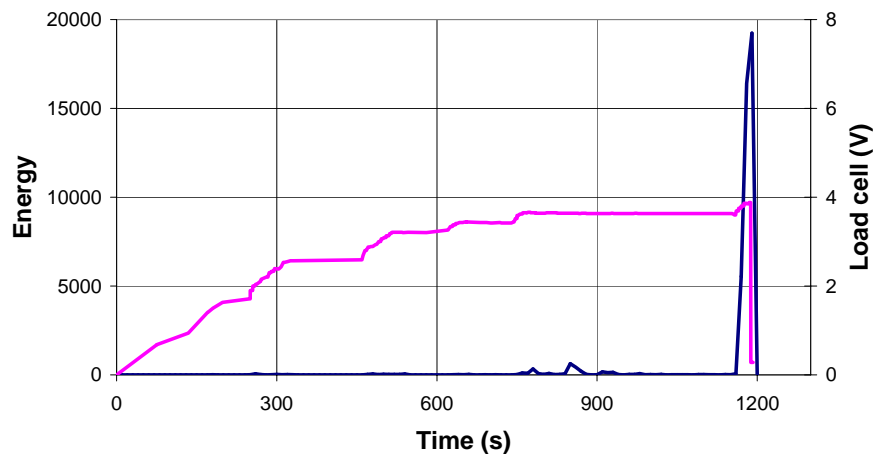
After inspection, the load was reapplied. Loading up to 3.63V again generated far less activity than the first loading (in accordance with the Keiser effect). At load hold for 3.63V however, activity was again registered at Spartan sensor 2. When the load was increased further, the blade failed at the 15.3m loading yoke. Blade failure occurs at 3.88V, thus the final inspection of the blade prior to failure occurred after it had been loaded to 93% (3.63/3.88) of its ultimate strength. This gives far greater possibility of interpreting failure causes and investigating initial damage than only having access to the destroyed structure and attempting to infer causes during a “post-mortem”.

Figure 34 Stress wave activity during the second loading of blade section 2.
